Alaska Department of Transportation & Public Facilities

Dalton Highway Flood Response Disaster in the Arctic

PNS Snow Conference 2016

June 7, 2016

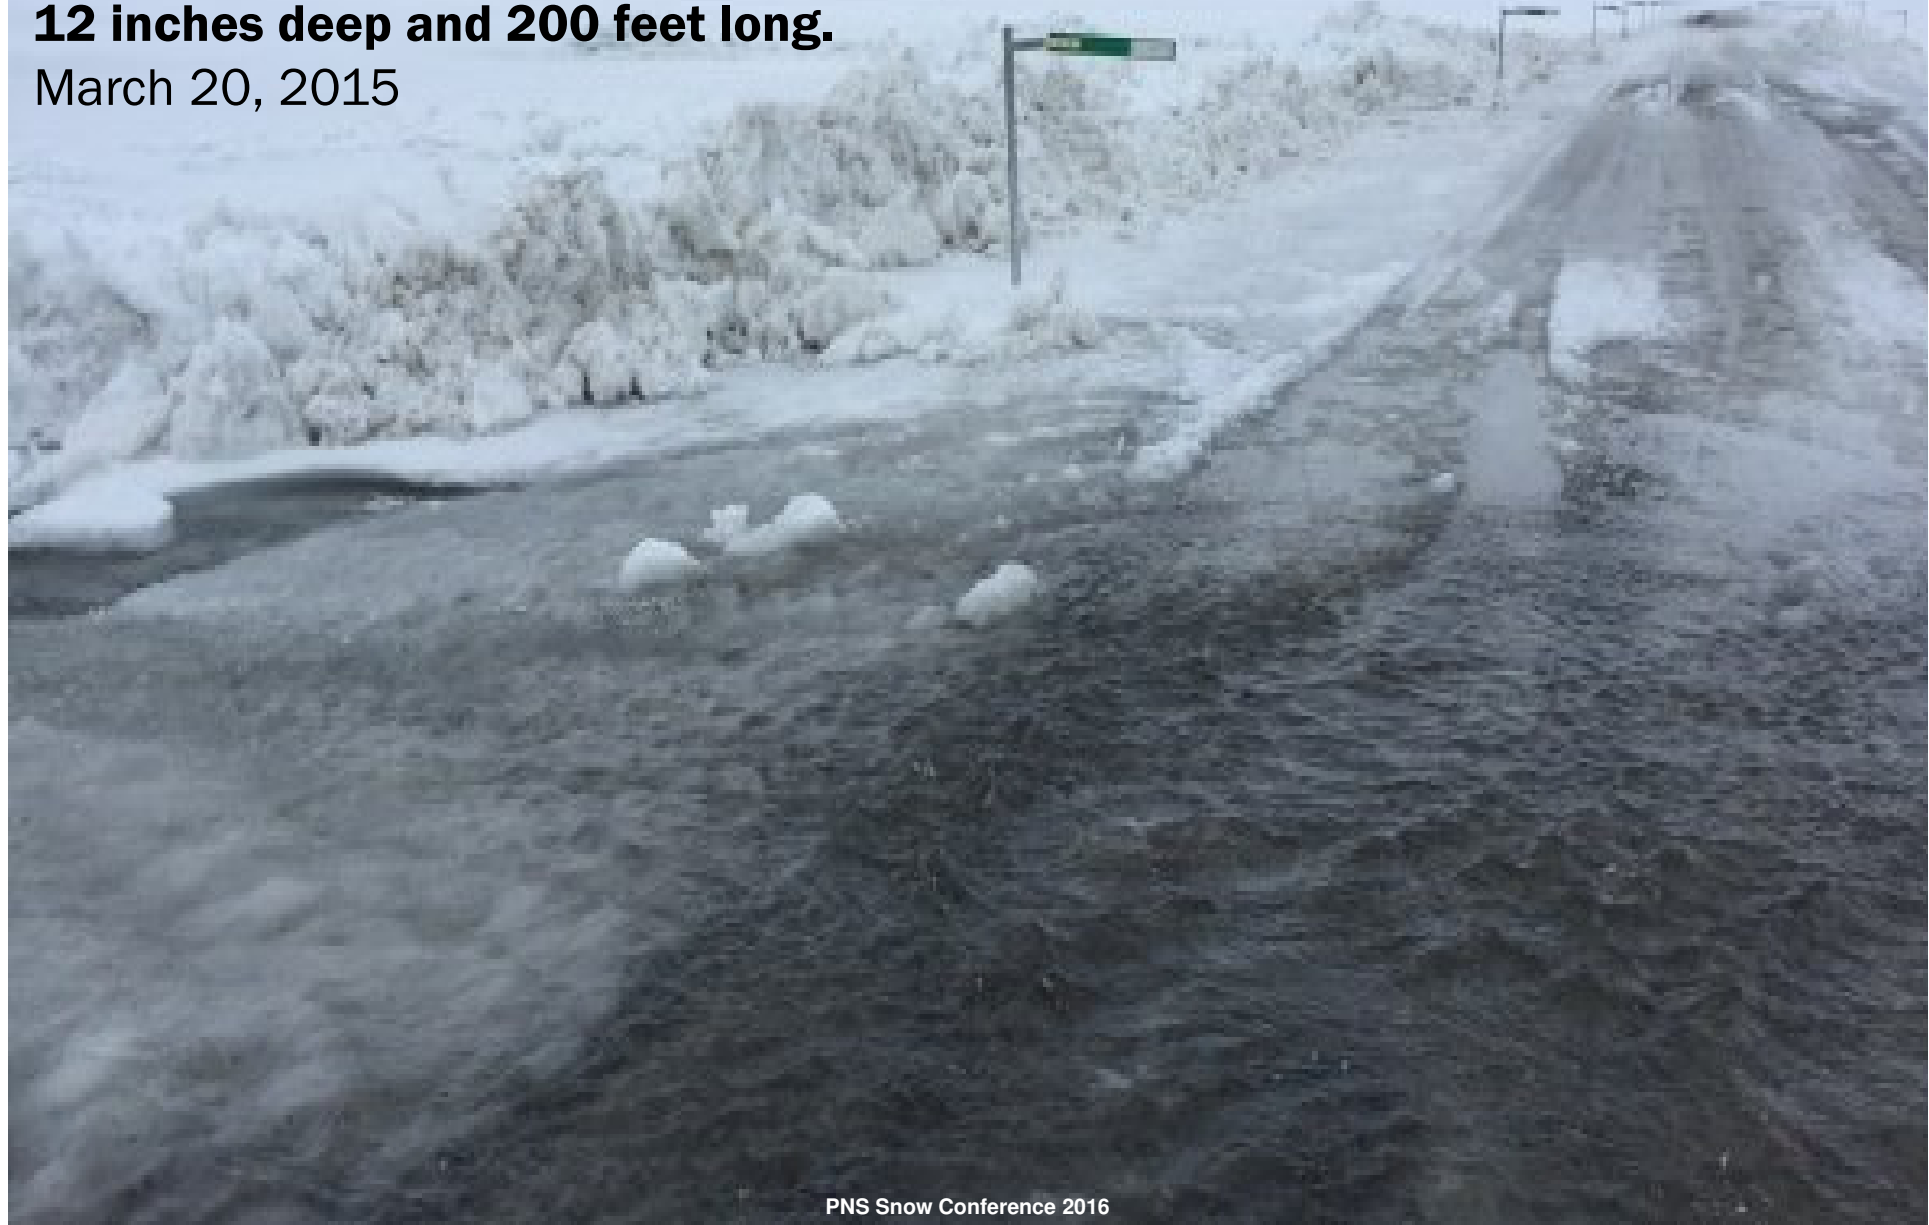
March 20, 2015

Dalton Hwy MP 396-405 - crews are working with Alyeska Pipeline Service Company to minimize overflow from the Sag River. The river is currently over the highway in eight locations, the largest spot is 12 inches deep and 200 feet long.

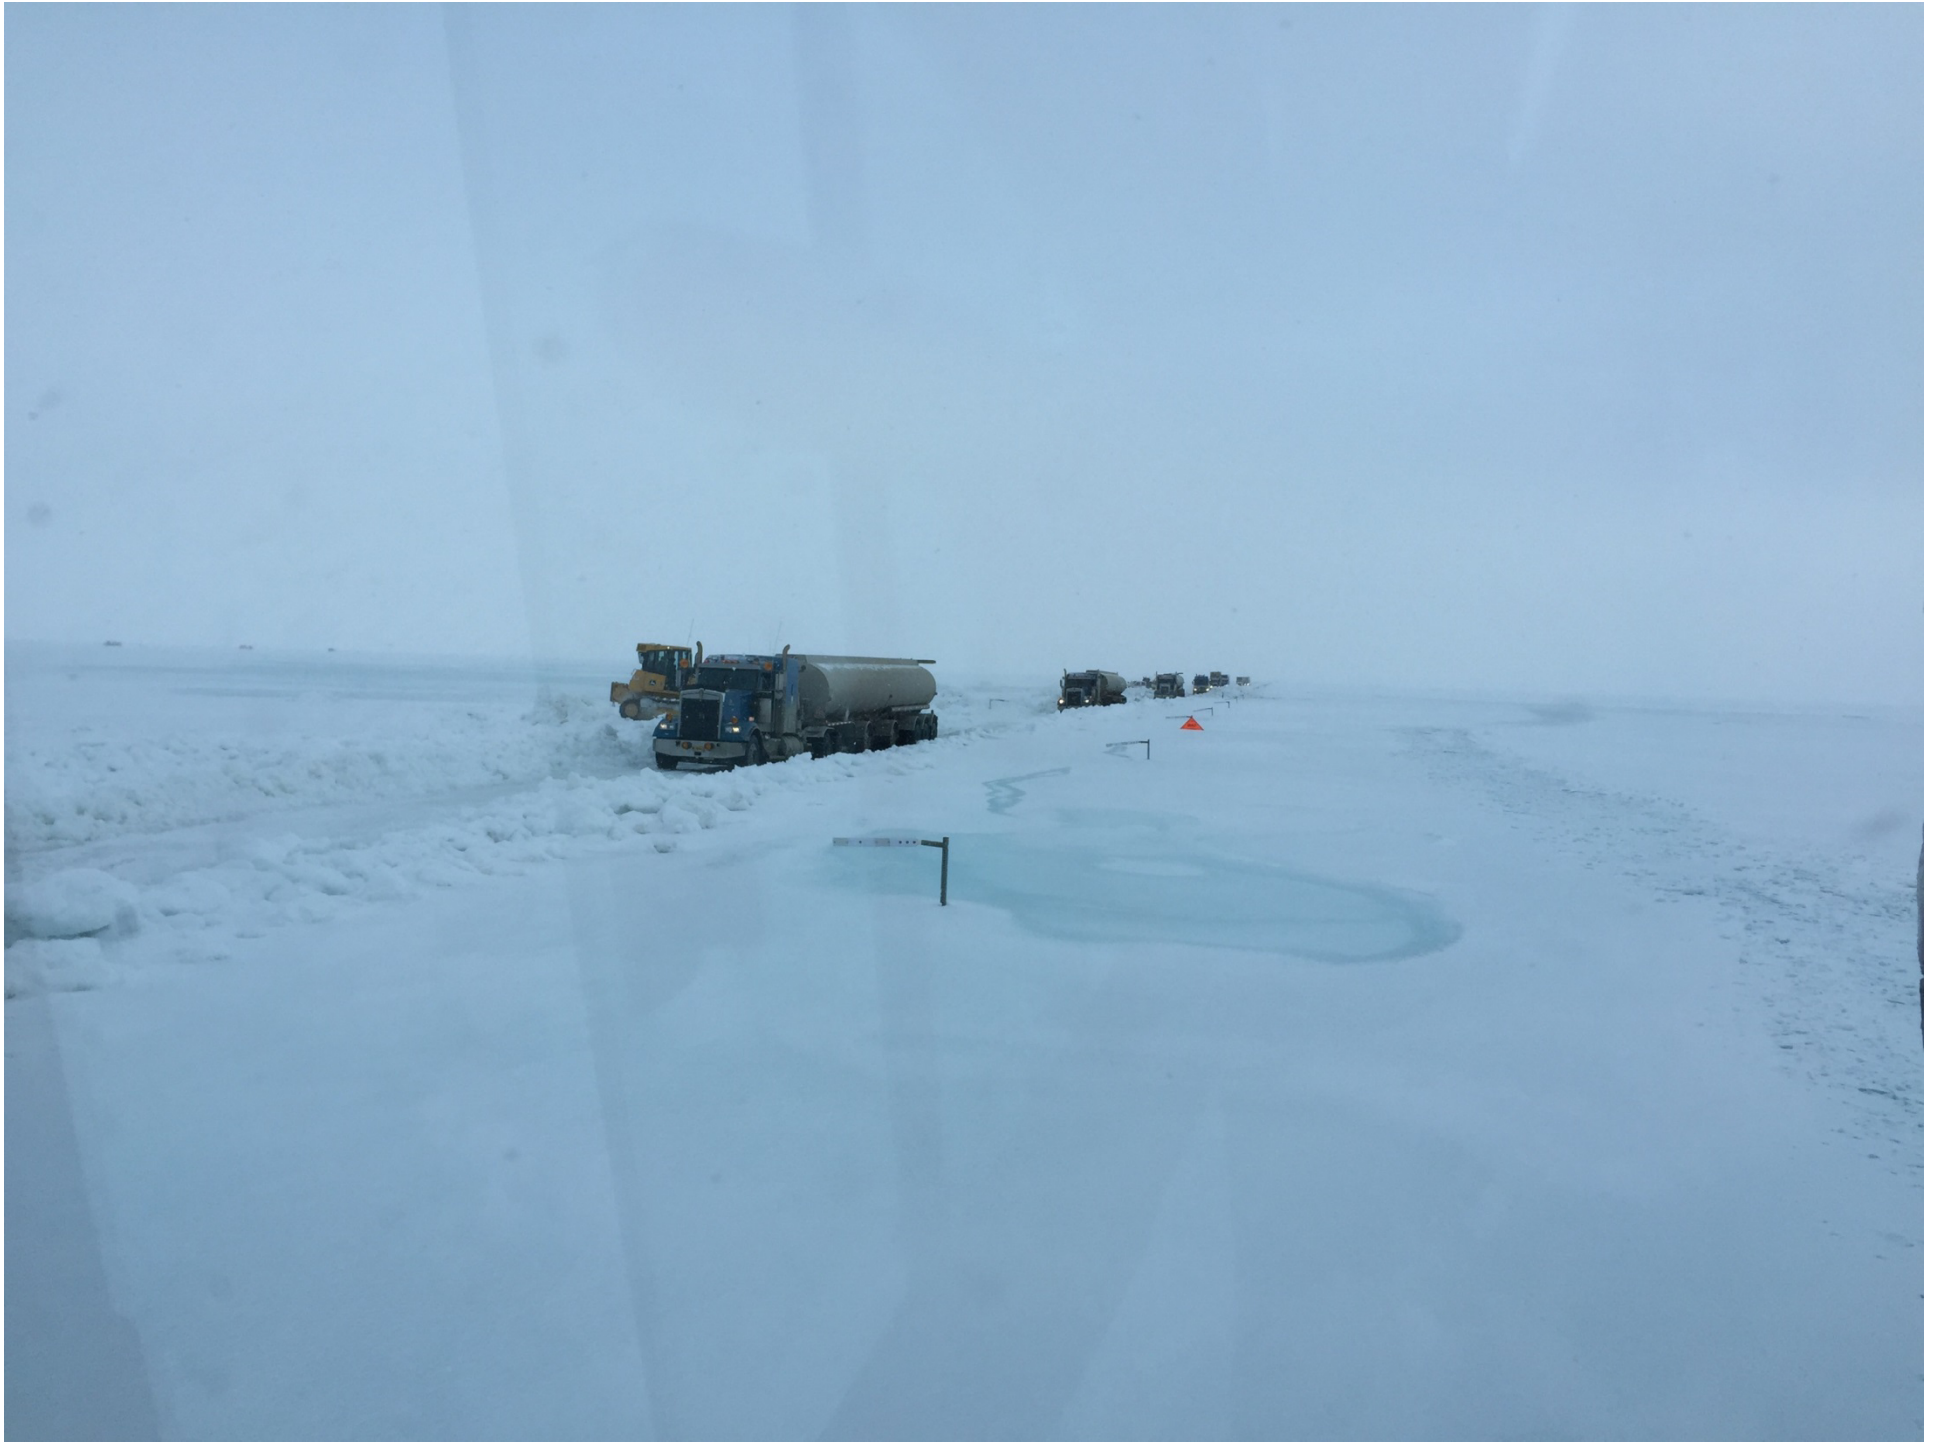
April 5, 2015

Aufeis flooding causes prolonged closure of the highway, south of Deadhorse

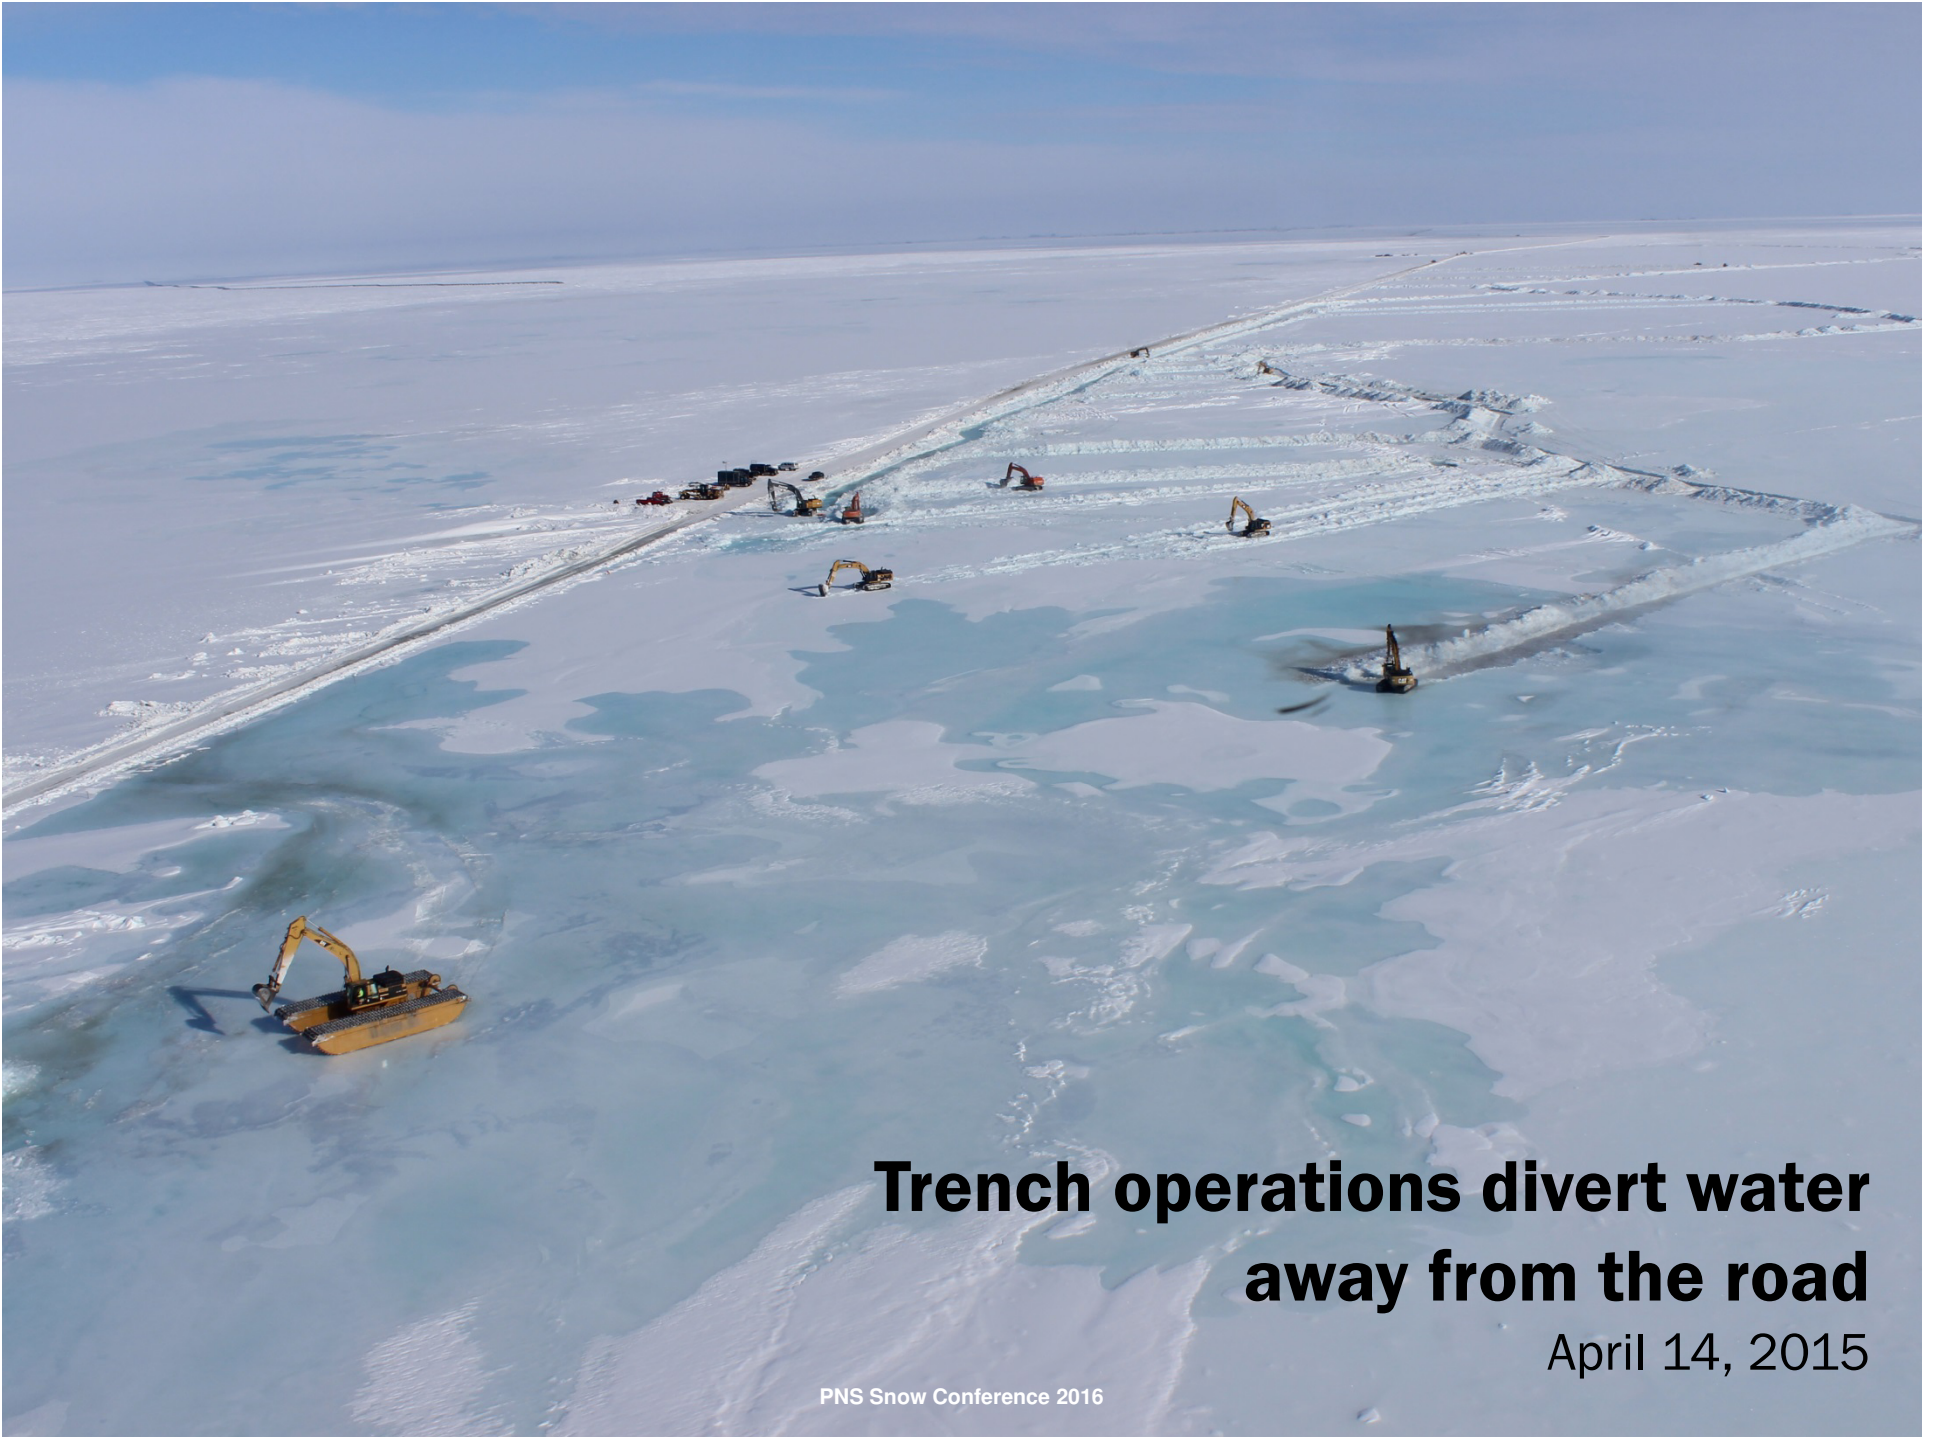
April 14, 2015

**Trench operations divert water
away from the road**

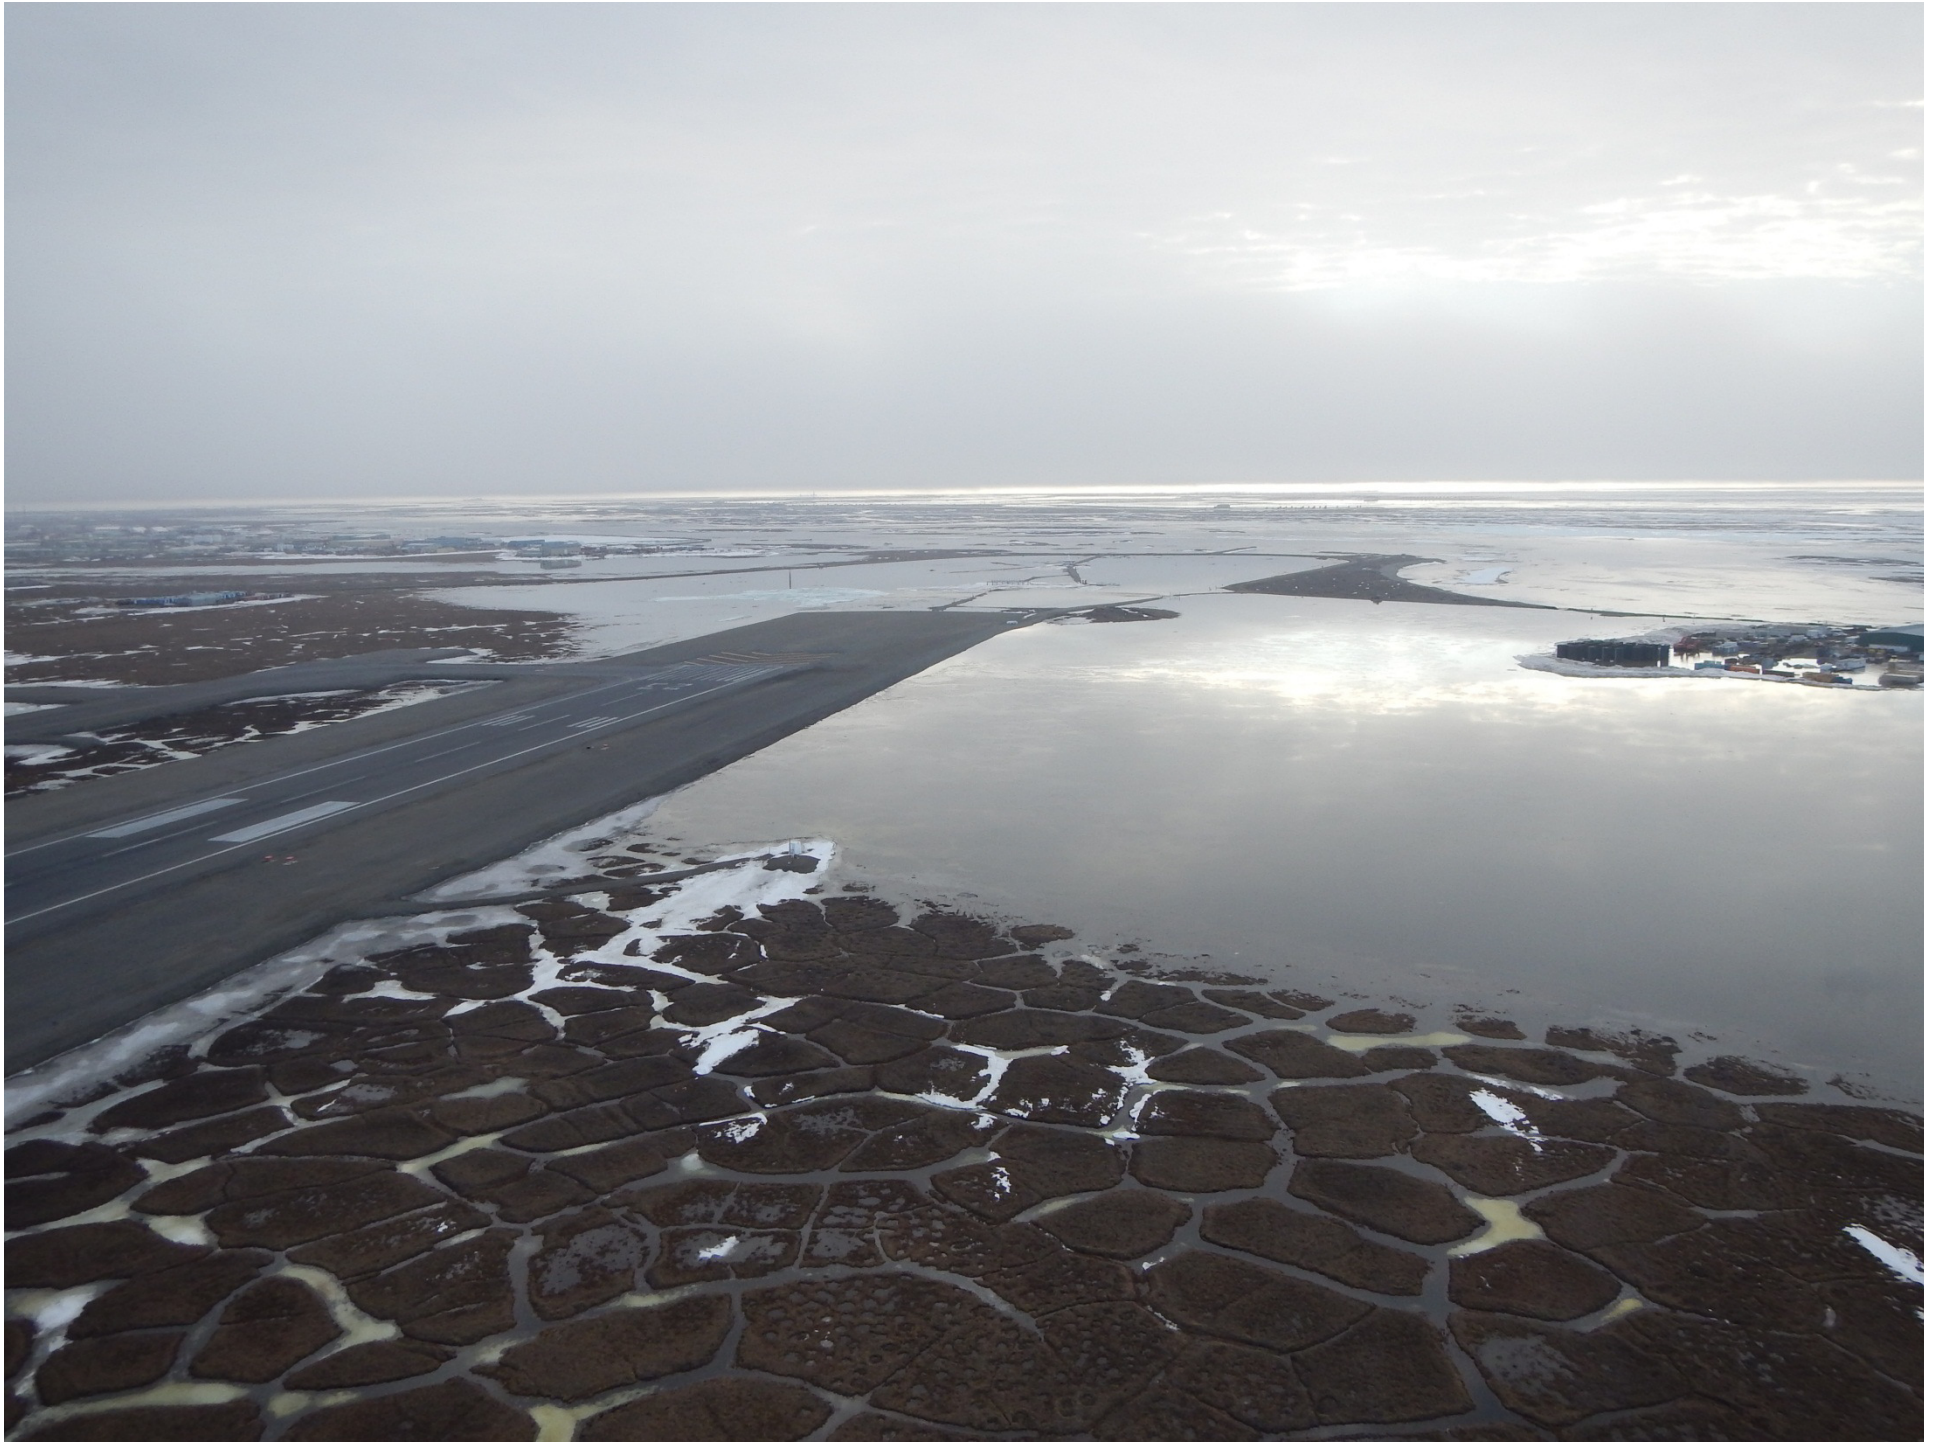
Water Relief Trenches

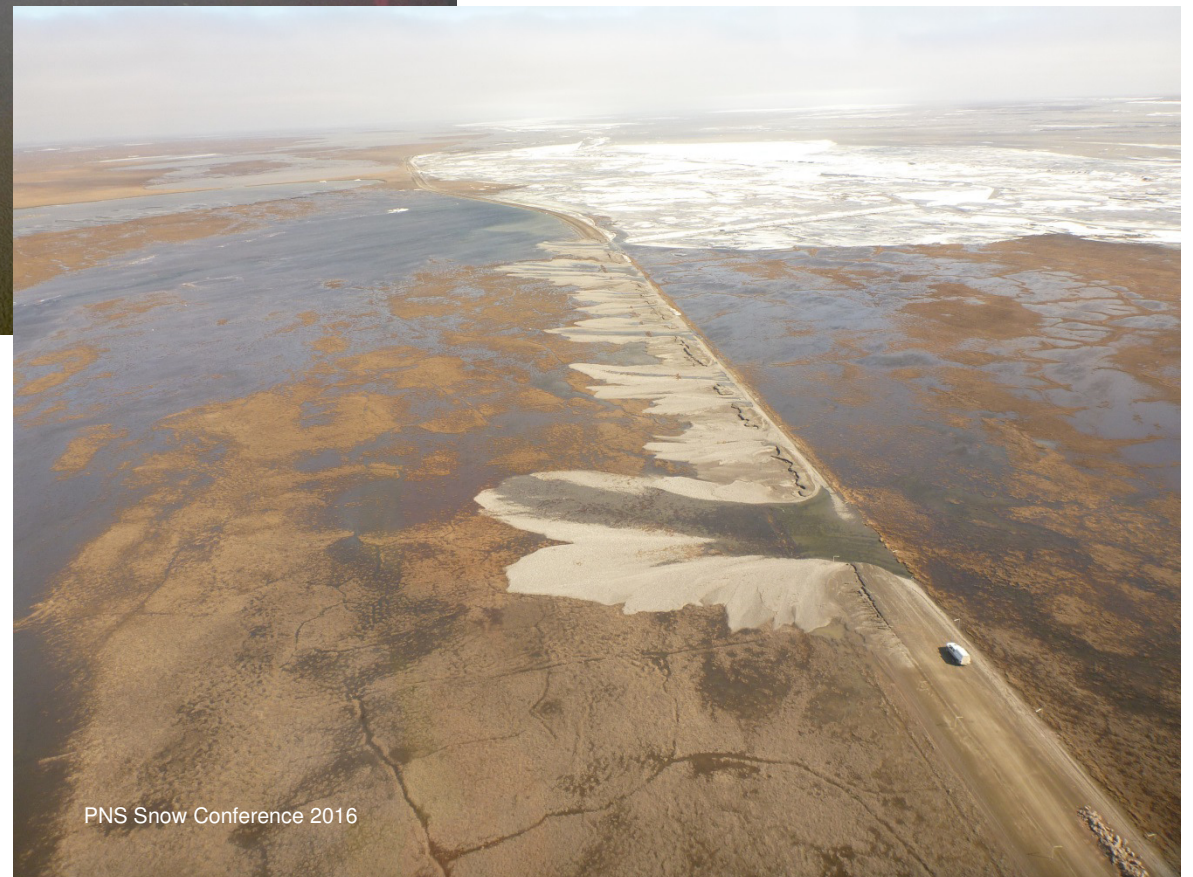
May 24-25, 2015

**Water recedes
dramatically
in a day, near
Mile 394**

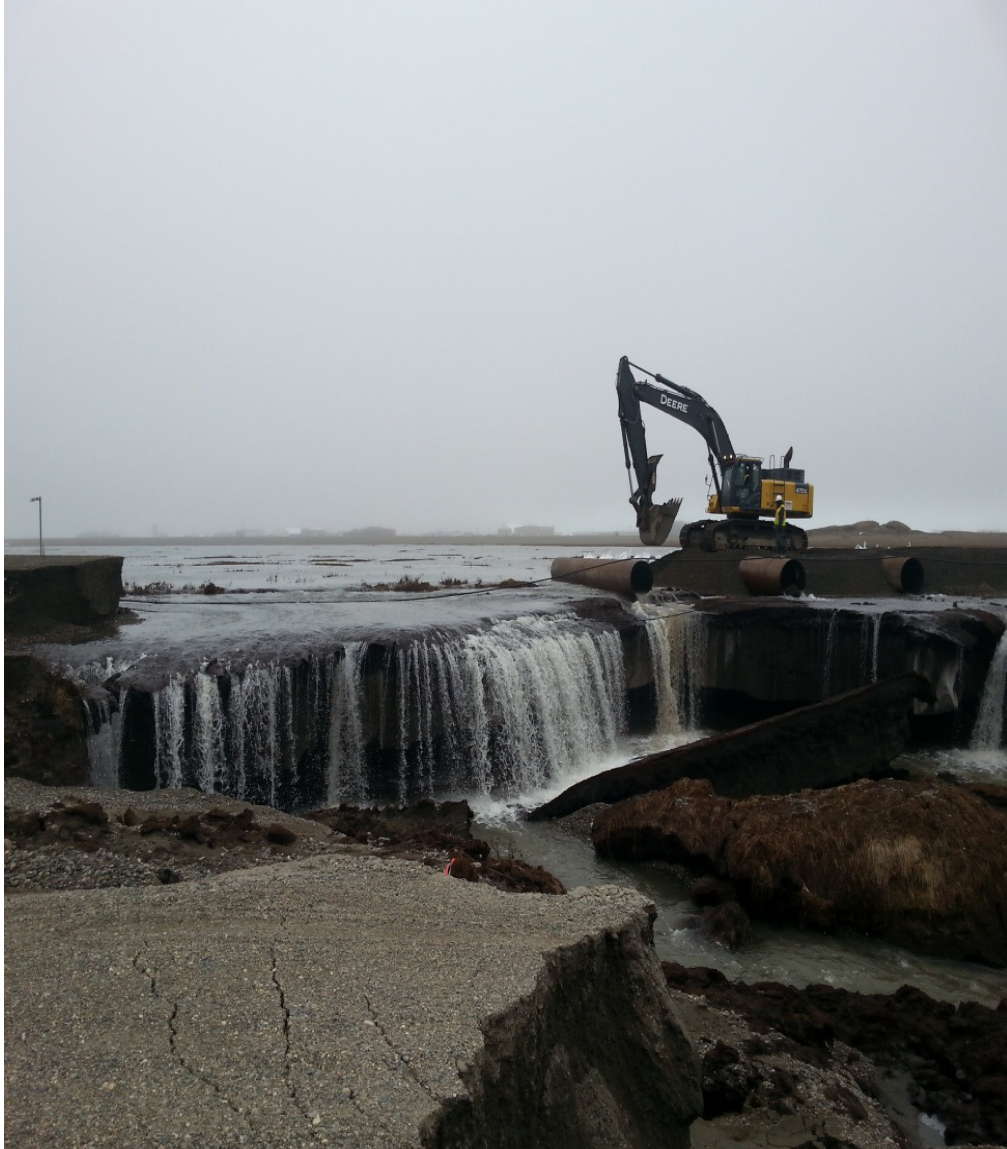
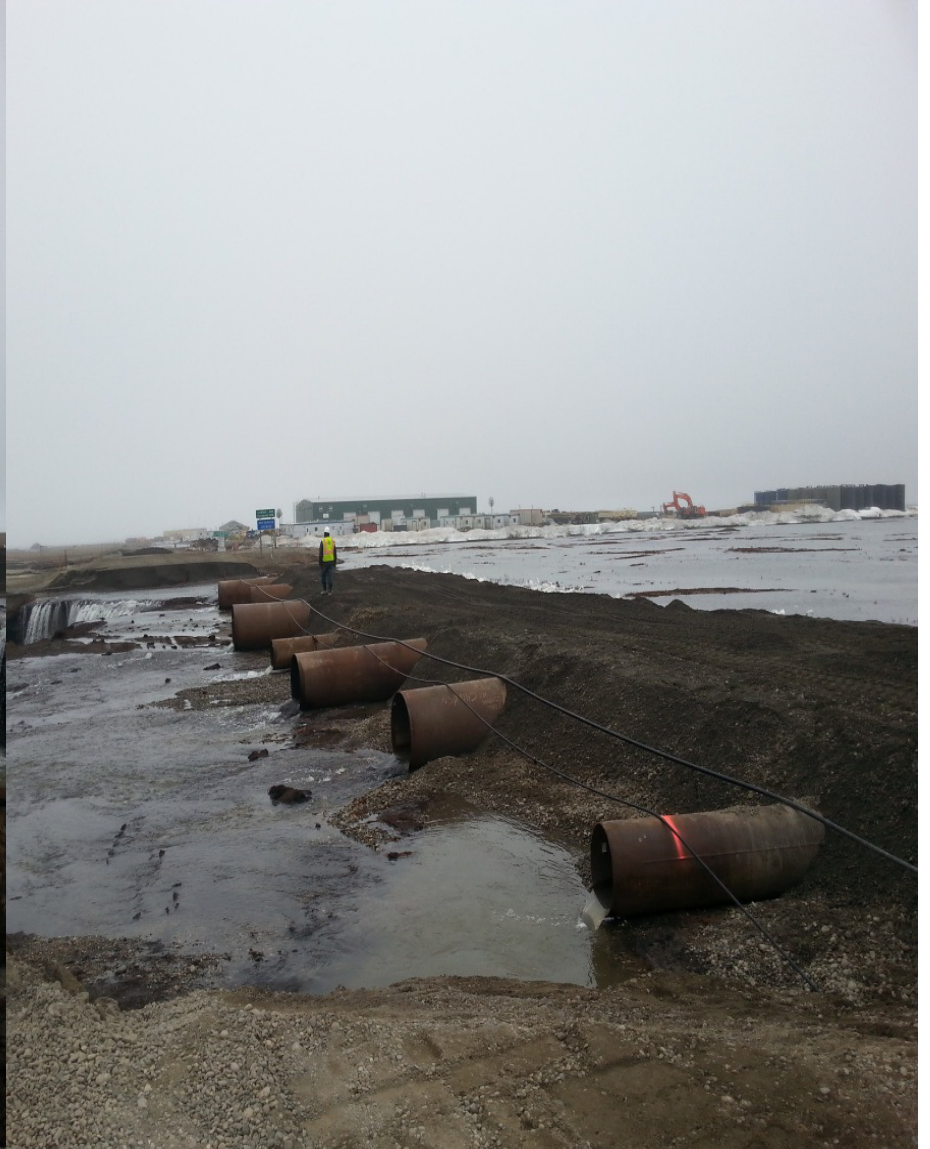
Emergency Repairs

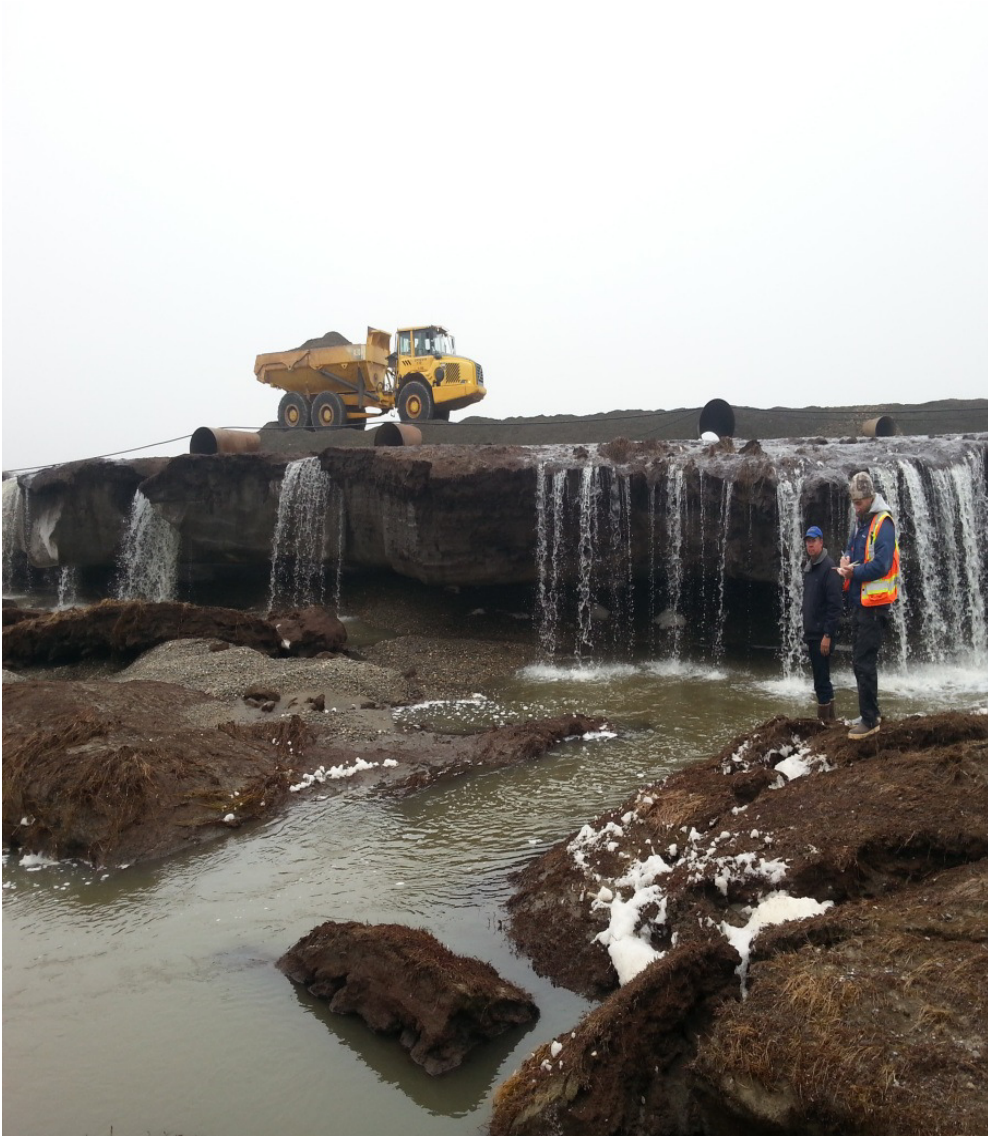
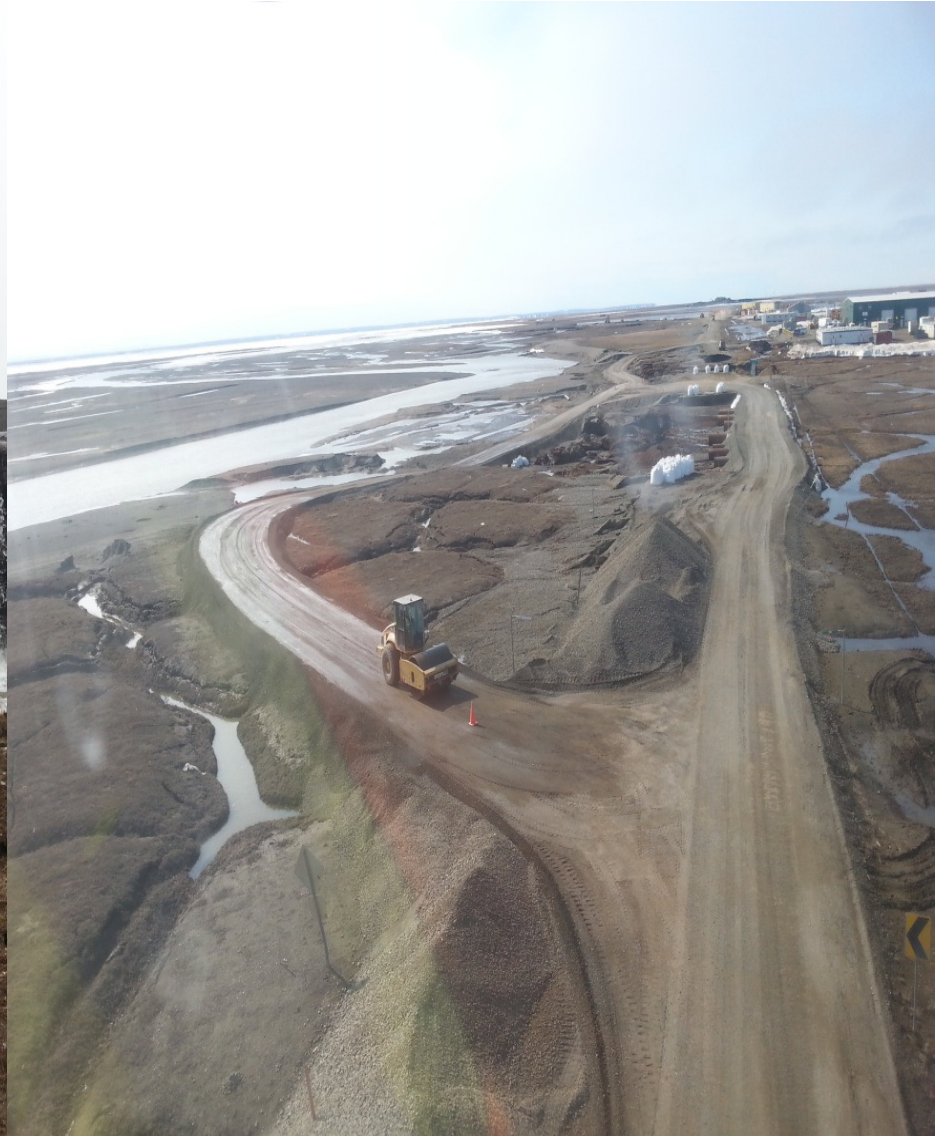
Emergency Repairs

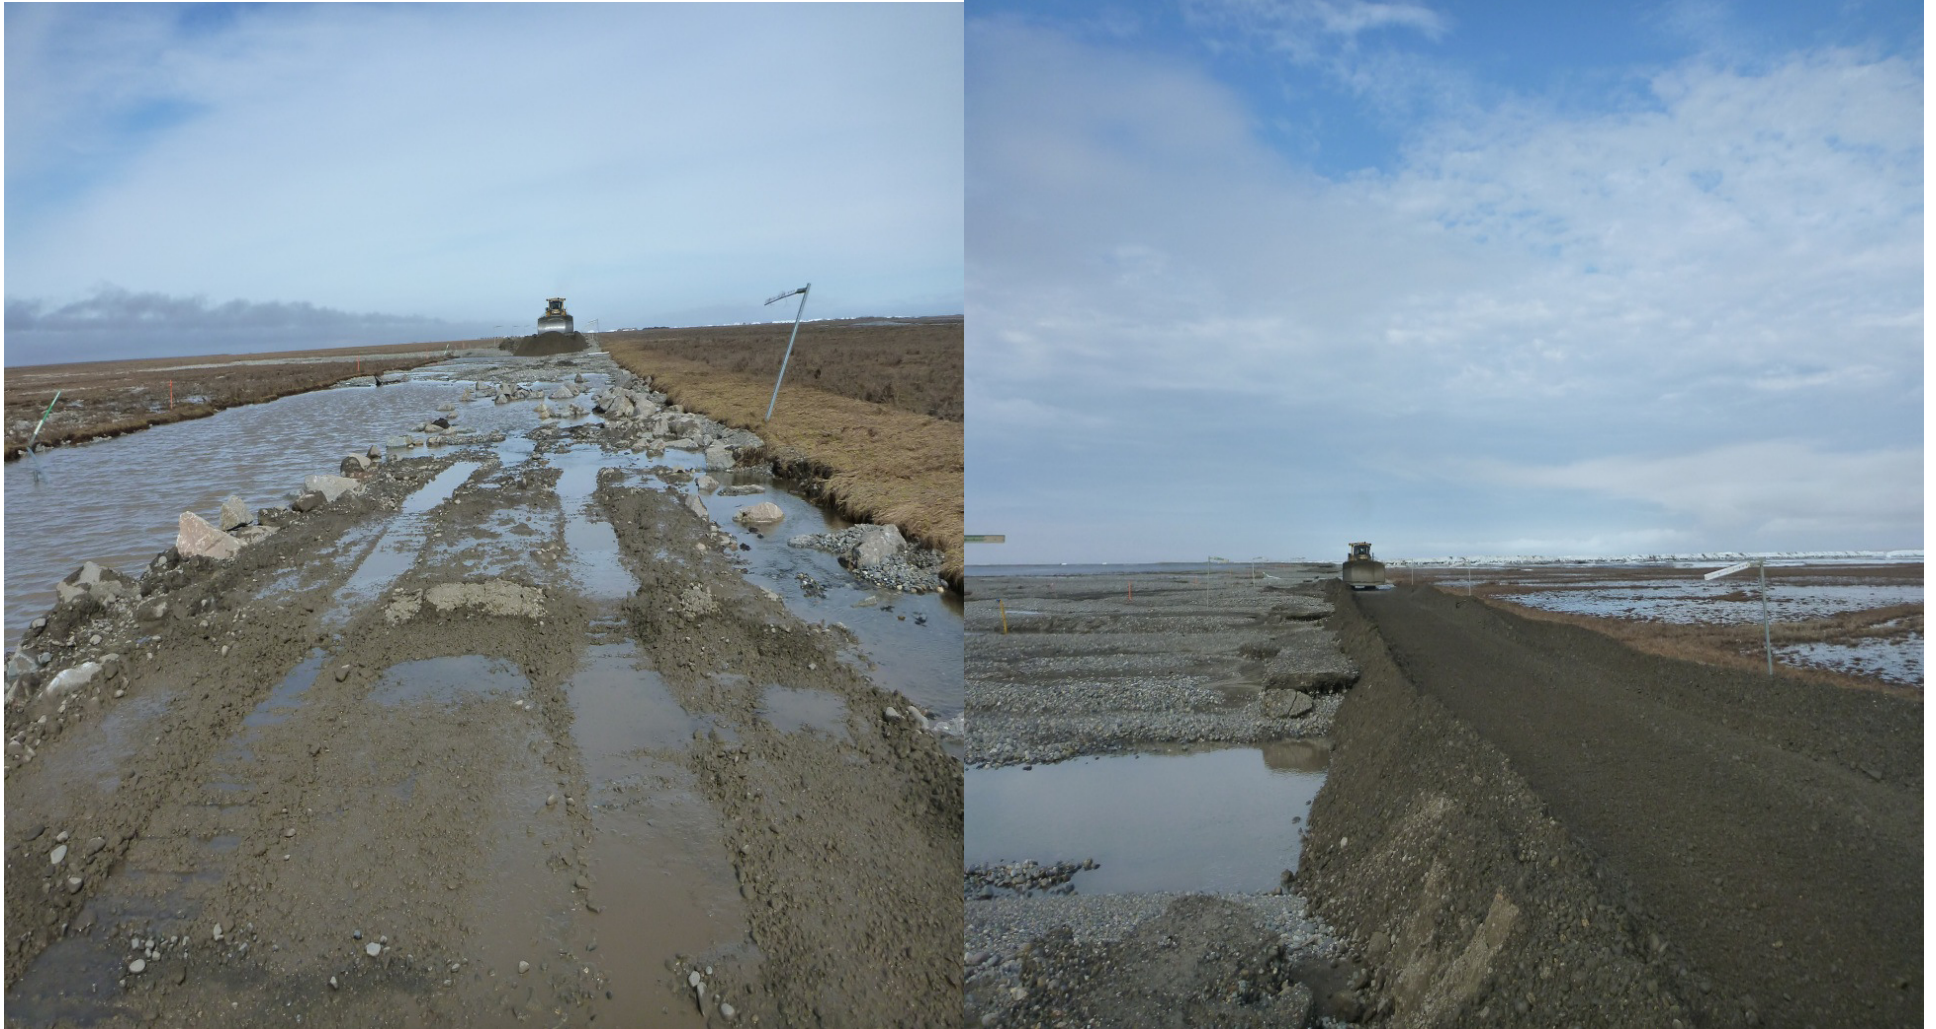
Emergency Repairs
